Docket No. 217 – Development and Management Plan Inspection

Northeast Utilities Service Company Certificate of Environmental Compatibility and Public Need for the construction of a 345-kV electric transmission line and reconstruction of an existing 115-kV electric transmission line between Connecticut Light and Power Company's Plumtree Substation in Bethel, through the towns of Redding, Weston, and Wilton, and to the Norwalk Substation in Norwalk, Connecticut.

Date: November 23, 2005

Location: Norwalk Substation Expansion

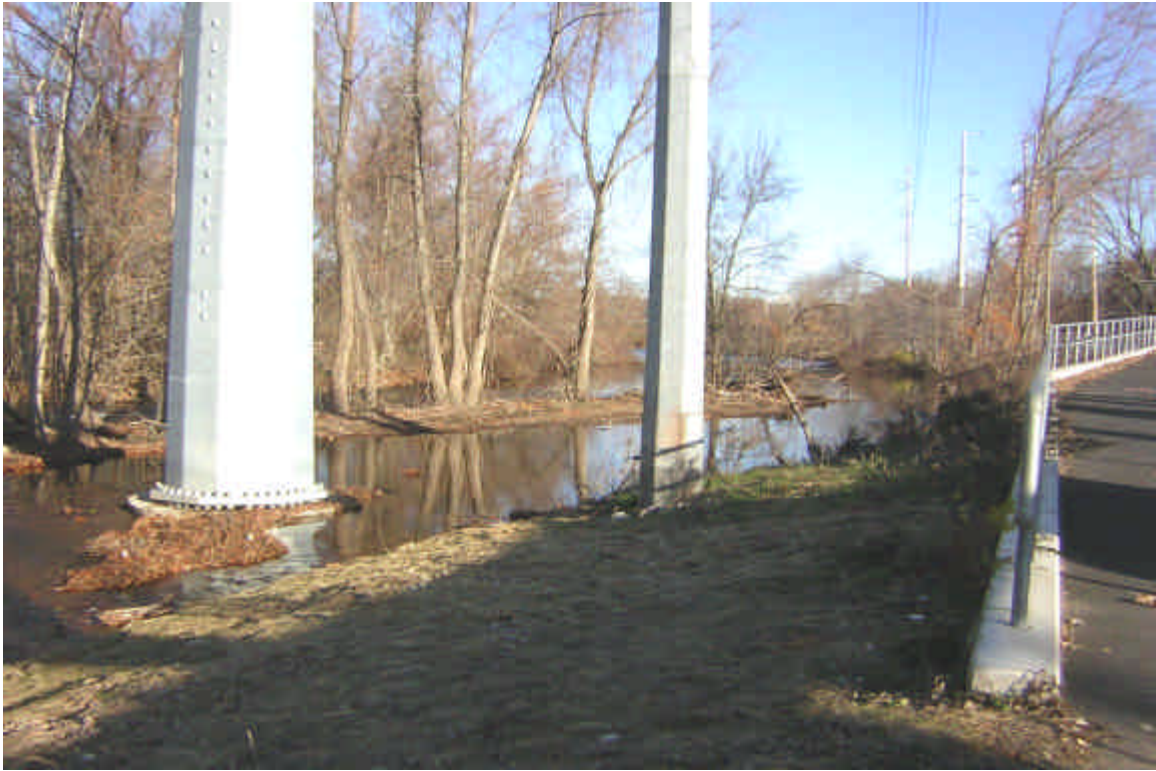
Inland Wetland and Watercourse encroachment and mitigation	<p>-The 345kV work area appears to have been restored and mulch has been applied to the side slopes. 11/10-11/23/05</p> <p>-Sediment was noticed at the edge of the constructed overflow channel and the river but the water is running clear through the entire area.</p>	- Continue to remove any loose sediment due to the project in the channel and work area. 11/23/05.

Norwalk Substation: View of the Turning Structure and the restored portion of the natural overflow channel. 11/23/05.

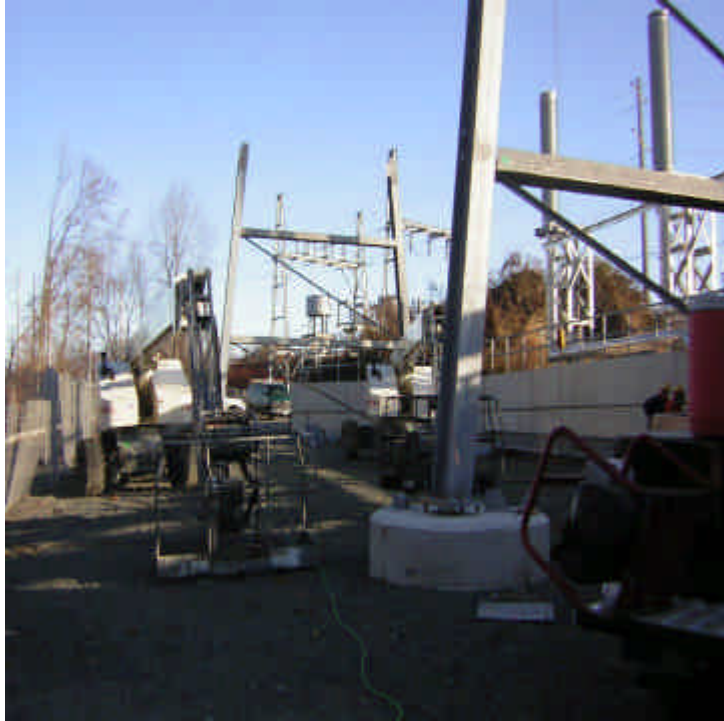
**Photo on the left shows the structures being installed in the northwest portion of the yard.
Photo on the right shows the excavation work adjacent to the GIS building nearing completion. 11/23/05.**

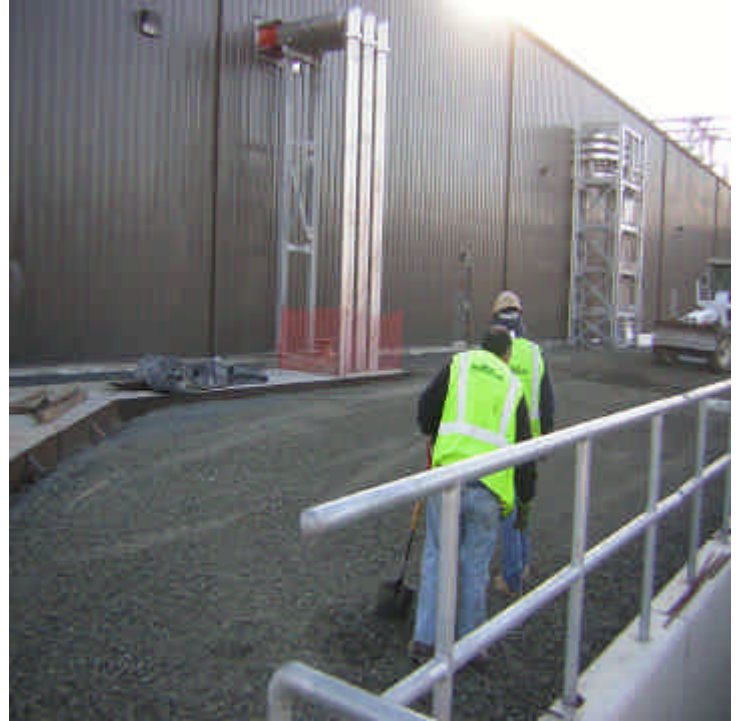
Areas of Inspection	Observation	Recommended Action
	northern portion of the site near the ROW. 11/23/05	
Erosion and Sediment Controls	- The catch basin at the southwest corner of the GIS building has some observable sediment accumulation as the original protective fabric here is wearing out. 11/10/05-11/23/05	- The catch basin is going to be cleaned out and a new silt sak will be installed. 11/17-11/23/05
Erosion and Sediment Controls continued (includes inspection within 24 hours of a storm event)	<p>- Sedimentation from the access road off the Rt. 7 ramp was noted in the vegetated perimeter swale but it did not leave the site. 9/21/05-11/23/05.</p> <p>-The constructed overflow channel had some accumulated sediment at the edge of the river due to the flooding and potentially the adjacent fill work. 10/27/05-11/23/05.</p> <p>- It appears that all temporary fill has been removed from the work area and a gravel bottom remains in the natural overflow channel. The channel was flooded at the time of inspection and the water was clear, with no signs of sediment. Hay mulch has been applied to the disturbed slopes where some grass growth was noted. 11/23/05.</p> <p>- A number of stockpiles are noted in the yard near the GIS building but they are all well contained. 11/23/05.</p>	<p>- Sedimentation and gravel remain contained within the swale. The access road will be paved eventually which will remove the problem. Continue to monitor area until final stabilization. 9/21/05-11/23/05.</p> <p>- Sediment may need to be removed by hand here in order to restore the original capacity of the channel. 10/27/05-11/23/05.</p> <p>- It should be confirmed the channel is at original grades. 11/10-11/23/05.</p> <p>- All piles are well within the site. None at this time. 11/23/05</p>

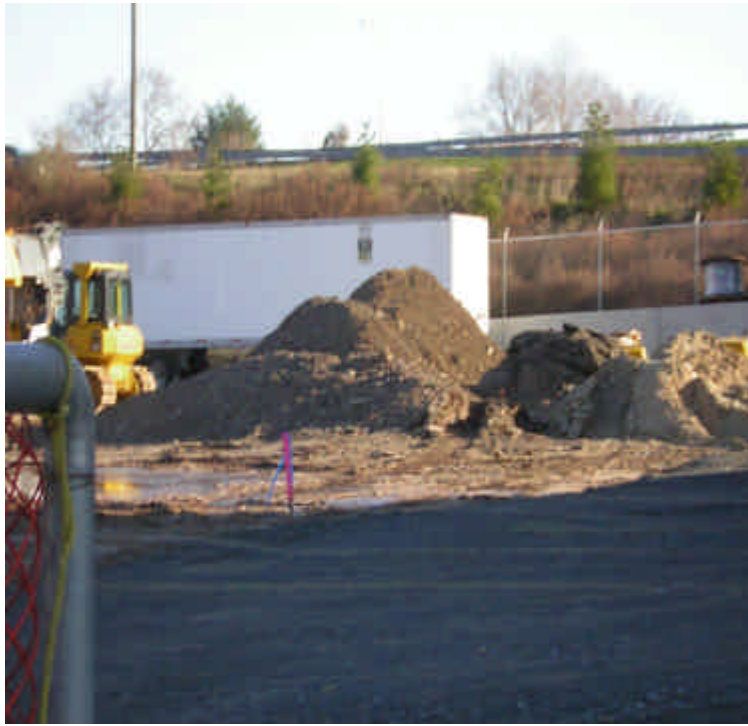
Photo on the left shows a view of the stockpiles placed near the GIS building. All soil remains contained on site. Photo on the right shows the natural portion of the overflow channel with the Norwalk River running fairly high. 11/23/05.

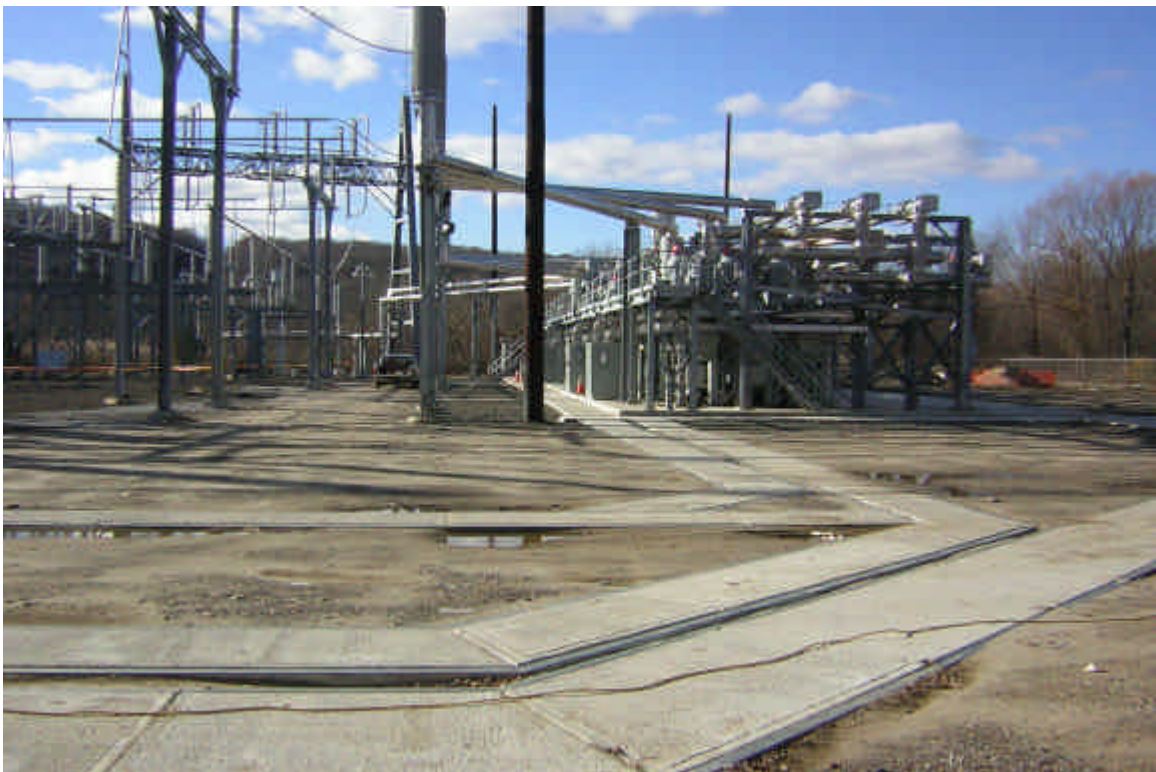
Plumtree Substation: Work internal to the pad continues. 11/23/05.
